# NATIONAL TRANSPORTATION SAFETY BOARD

## RAILROAD ACCIDENT REPORT

SIDE COLLISION OF  
TWO MISSOURI PACIFIC RAILROAD COMPANY  
FREIGHT TRAINS  
AT GLAISE JUNCTION,  
NEAR POSSUM GRAPE, ARKANSAS  
OCTOBER 3, 1982

NTSB/RAR-83/06

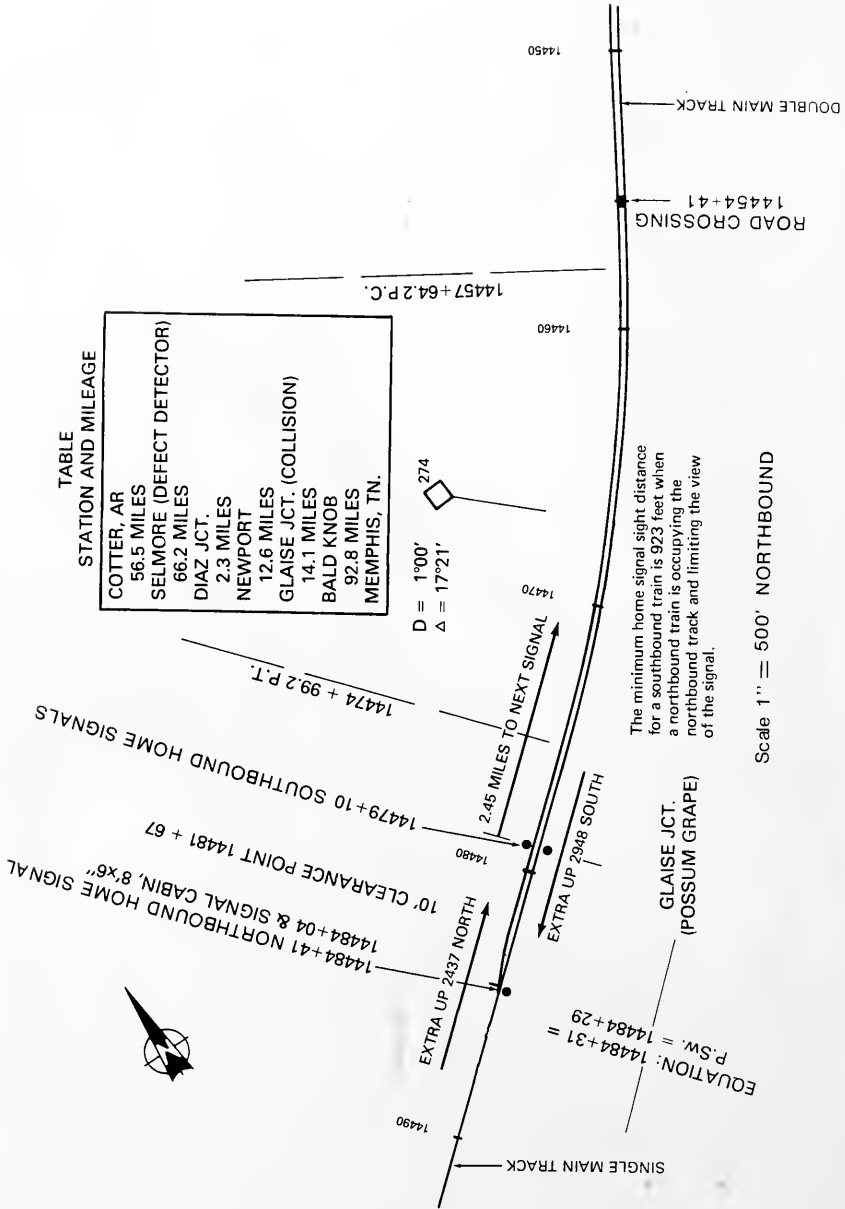
Figure 1.--Plan view of track at accident site.

initial terminal air brake test and was operated to Glaise Junction, Arkansas, a distance of 107 miles, without incident. The engineer was seated at the controls of the lead locomotive unit, and the fireman and head brakeman were seated in their respective positions on the left side of the same cab as the train approached Glaise Junction. The conductor and rear brakeman were in the caboose. About 4:13 a.m., as Extra UP 2437 North approached the Glaise Junction switch, the train dispatcher aligned the remotely controlled switch and signal to enable Extra UP 2437 North to exit the single main track and enter onto the west track of the two-track system north of that location. (See drawing, figure 1.)

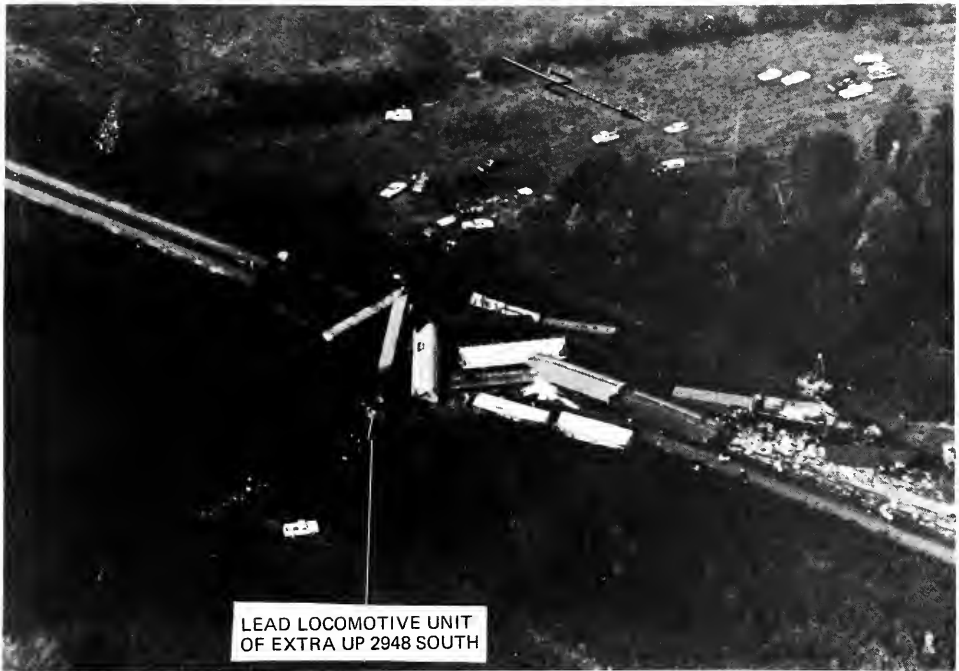
Figure 2.—Overview of collision/derailment site.

Trains.--The cab of the lead locomotive unit of Extra 2948 South was severely deformed during the collision and was deformed further as it rolled down the embankment on the east side of the fill supporting the track. Fuel oil leaked from the overturned unit's damaged fuel supply tanks and was ignited. The other locomotive units and nine following freight cars were damaged heavily. Damage to the train was estimated to be \$646,000. The eighth car from the rear and the following six cars in Extra UP 2437 North were damaged heavily as a result of the collision. The caboose and the car immediately ahead were not damaged. Damage to the train was estimated to be \$131,000. The combined loss of lading for both trains amounted to \$165,000.
